## The Bulletproof Canopy

By Lt. Nathan Barton

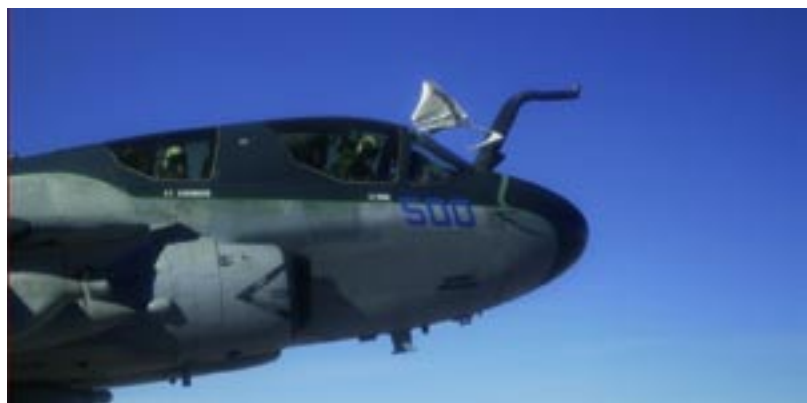
As soon as I saw the basket begin to come apart, I immediately went to idle and squeezed the speed-brake switch as hard as I could, as if to make them come out faster than normal. Pieces of debris showered the air. As the sine wave reached the end of the hose, the remains of the refueling basket detached from it. The solid metal valve, which spewed fuel all over our aircraft at 50 psi, still was attached to the end of the hose. It began to violently whip up and down, beating relentlessly on the canopy and nose of the aircraft. Were we not in a jet that had an extremely thick, bulletproof canopy, the basket surely would have sliced through the glass, clearing out anything in its way.

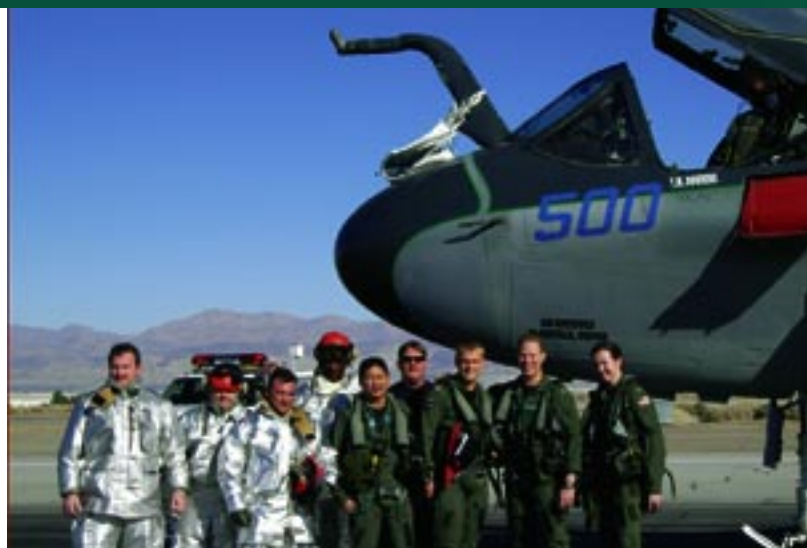
Our EA-6B suffered irreparable FOD damage to our starboard engine from the ingested metal. Our refueling

probe severely was mangled and required replacement. The nose radome suffered damage from the whipping hose and valve, and the carbon-fiber cover that protects the receivers in the vertical stabilizer had a hole through it. Fortunately, the canopy could be repaired. The KC-10 was forced to jettison the remains of their hose onto the desert floor, requiring replacement of the refueling hose and basket.

The investigation showed the refueling drogue had a catastrophic failure of the MA-4 coupler upon contact with the refueling probe. This contact caused the basket to detach from the refueling hose. The hose-reel-retract system, which they were troubleshooting when we arrived, wasn't working and caused the abnormal sine wave. The final cost of parts and man-hours topped \$300,000. This was but a small price to pay in comparison to what could have happened had that small piece of nylon not held up in 280 knots of wind for the 30-mile divert to China Lake.
